Eagle House
25 Memorial Drive
Lunenburg, MA 01462

Property Condition Assessment

February 23, 2018

VERTEX Project No: 48237

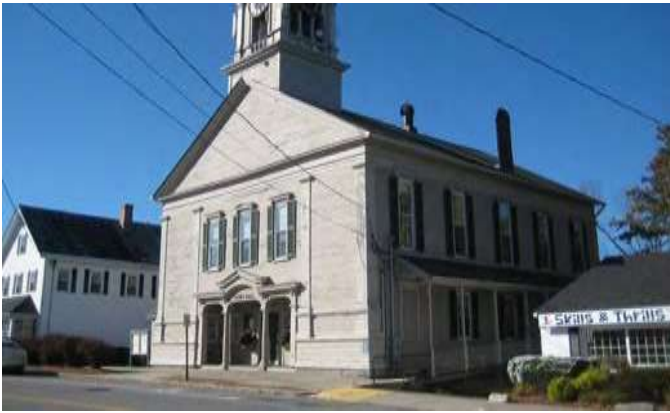
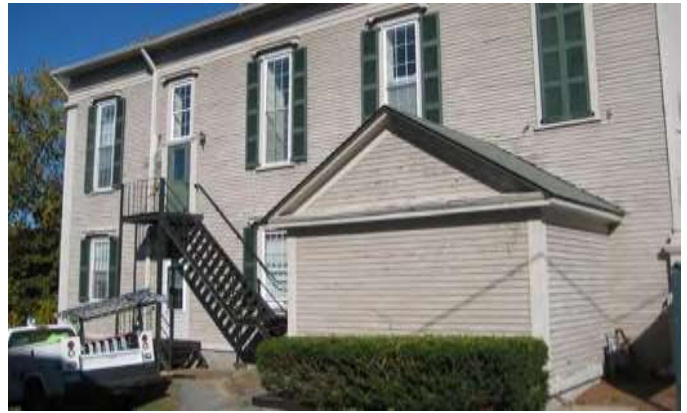
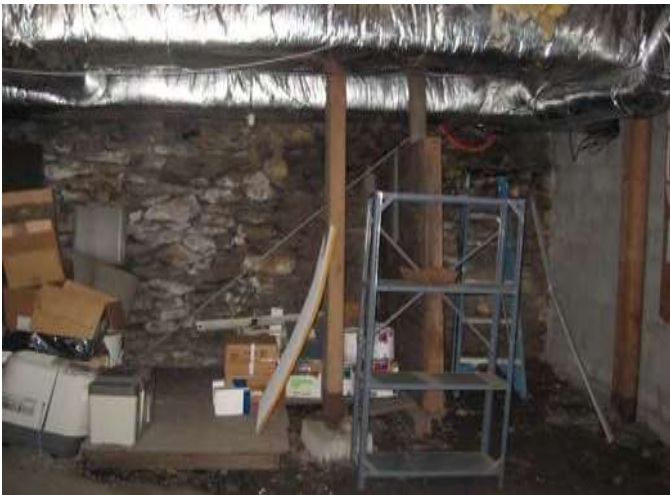
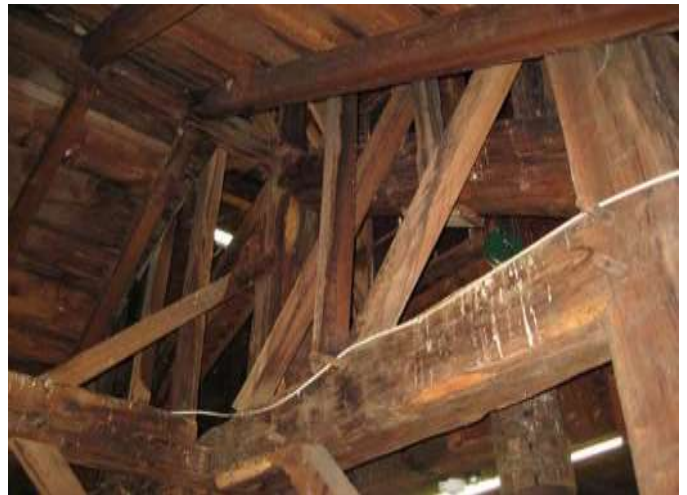
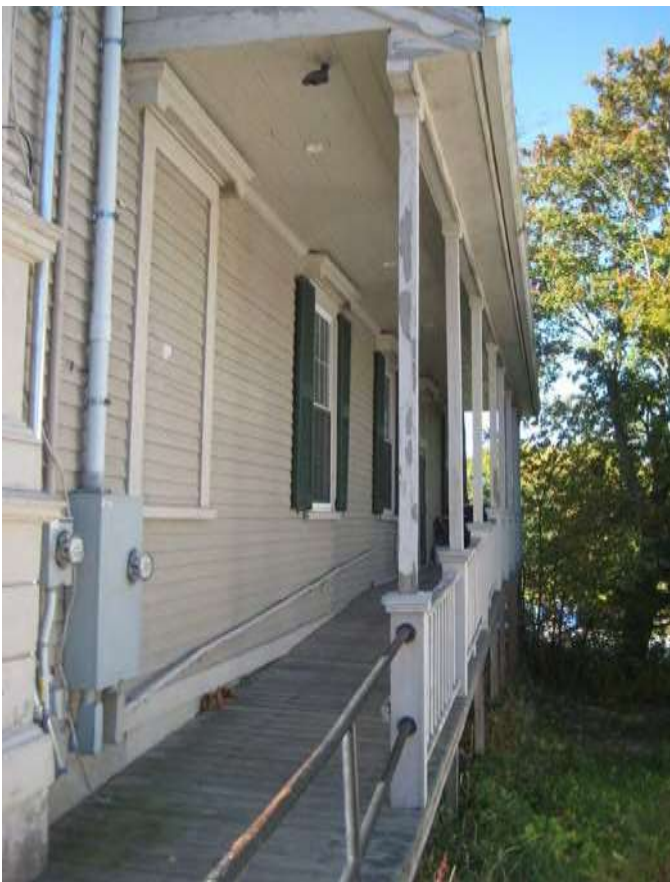
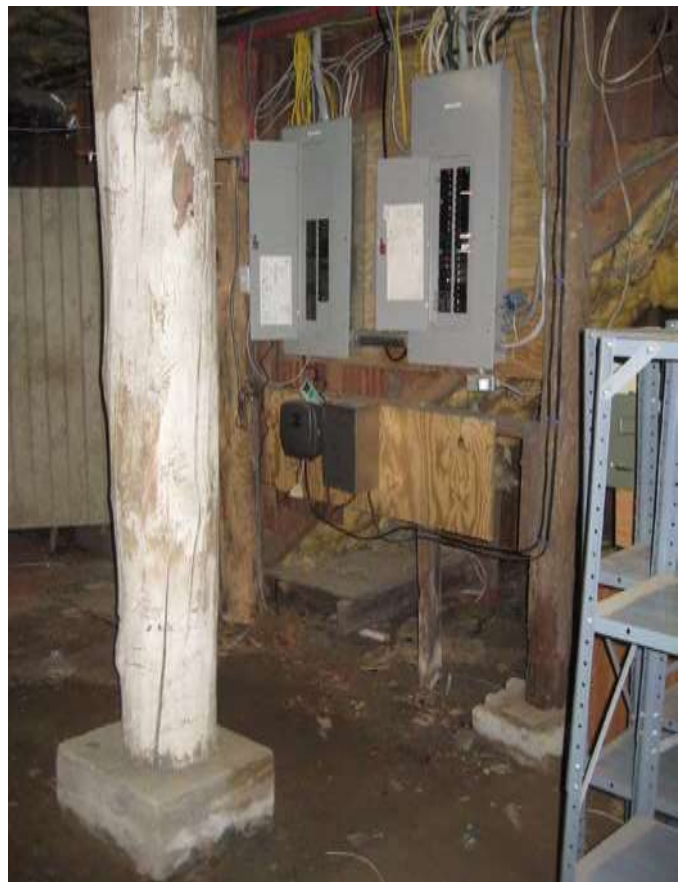
EXISTING CONDITIONS-TOWN HALL & PASSIOS SCHOOL

The building is a wooden post and beam structure and wood framing and siding. There is evidence of some rot in structural members and excess deflection of some floor joists. There has been some water infiltration into the building from the roof and possibly through the foundation walls which are stone. There is a relatively detailed inspection report from 2013 that can be used as a guide to the condition of the building. It should be anticipated that at some point, a structural and envelope upgrade should be undertaken to stabilize the building and upgrade the building envelope. Consideration might also be given to upgrades to the electrical systems.

The Passios was constructed in 1952 with an addition constructed in 1976. The building is approximately 55,000 SF on one level. The building is in good condition and the Town has made periodic investments in upgrades and enhancements.

The building is a steel frame structure with a brick exterior and wood plank roof framing. Systems in the building are in generally good condition although the fire protection is in need of updating and there is no air conditioning presently. It is recommended that lighting within the building be upgraded and that bathrooms and toilet fixtures be replaced to meet code. It does not appear that classroom entrances have adequate clearances to meet accessibility code and consideration might be given to improving the layout of these locations.

Town improvements over time have included selective re-roofing, updated kitchen equipment and gym floor, accessible main entrance, replacement of some sprinkler heads. The building has asbestos containing materials within it including VAT flooring, plaster and caulking, pipe insulation as well as roofing materials that would require abatement if work was done to modify and upgrade the building.

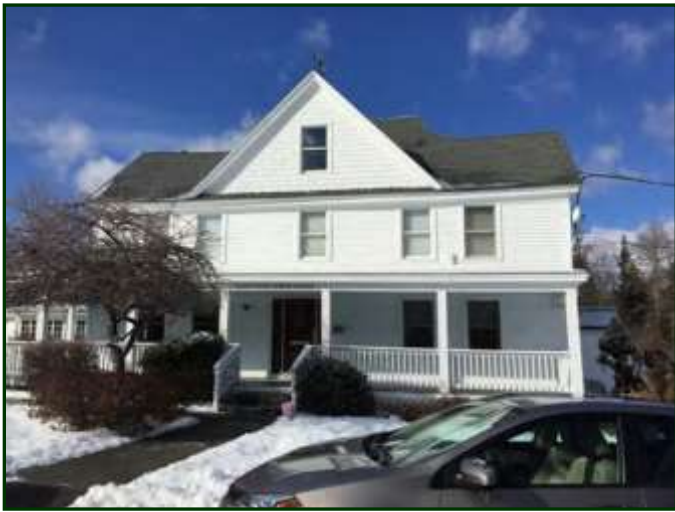
Photo #1: Photograph depicts general view of Side A of the Site Building.

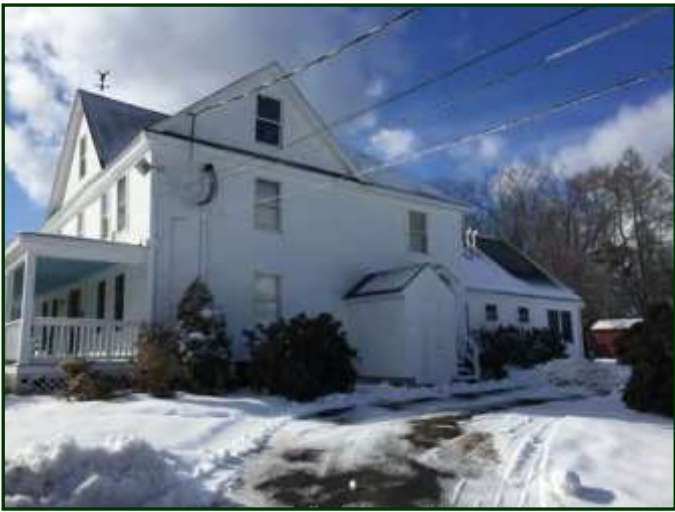
Photo #2: Photograph depicts general view of Side B of the Site Building.

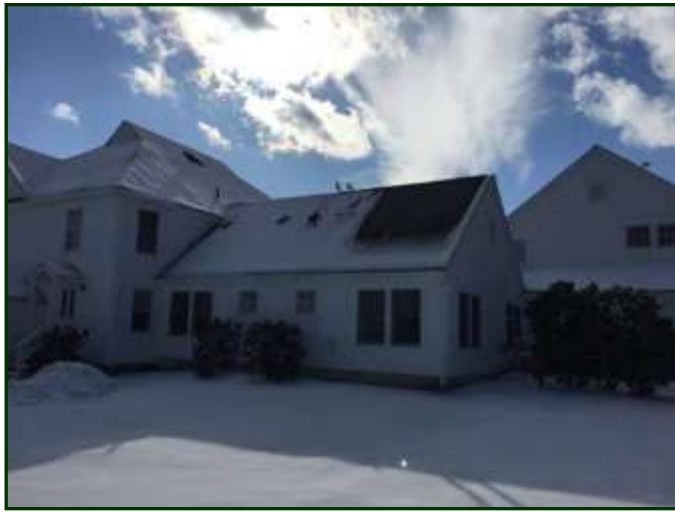
Photo #3: Photograph depicts general view of Side B of the Site Building.

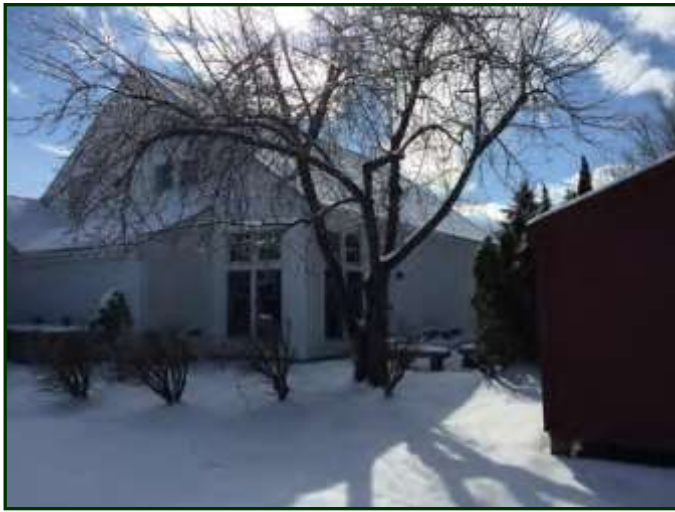
Photo #4: Photograph depicts general view of Side C of the Site Building.

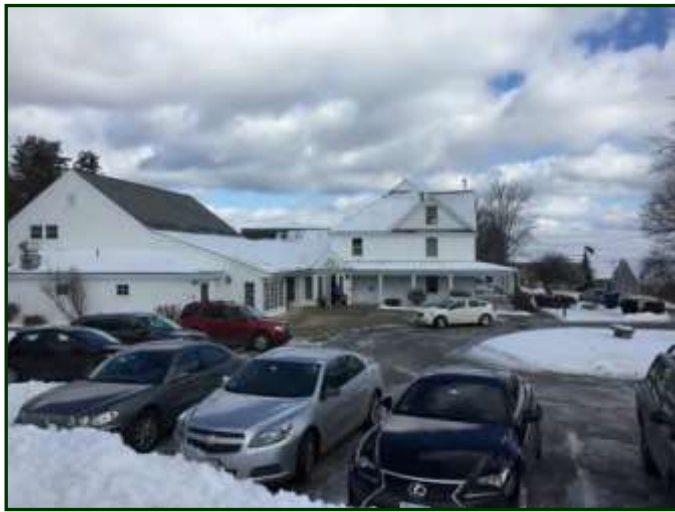
Photo #5: Photograph depicts general view of Side D of the Site Building.

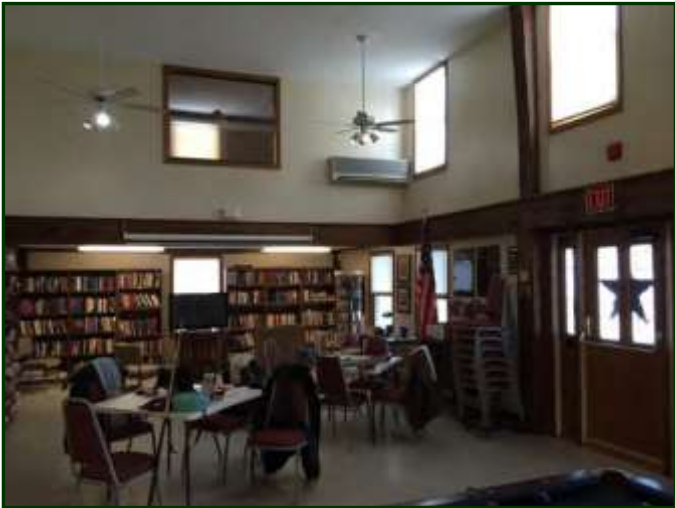
Photo #6: Photograph depicts general view of First Floor Interior of the Original Section .

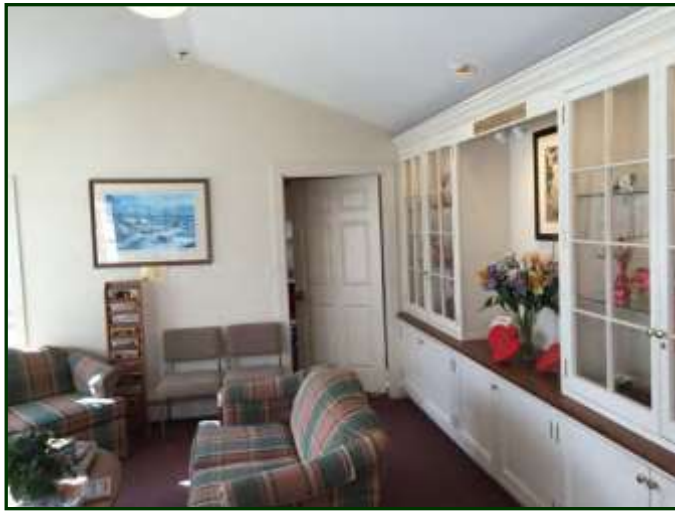
Photo #9: Photograph depicts general view of the Lobby/ Lounge Area in the Addition Section.

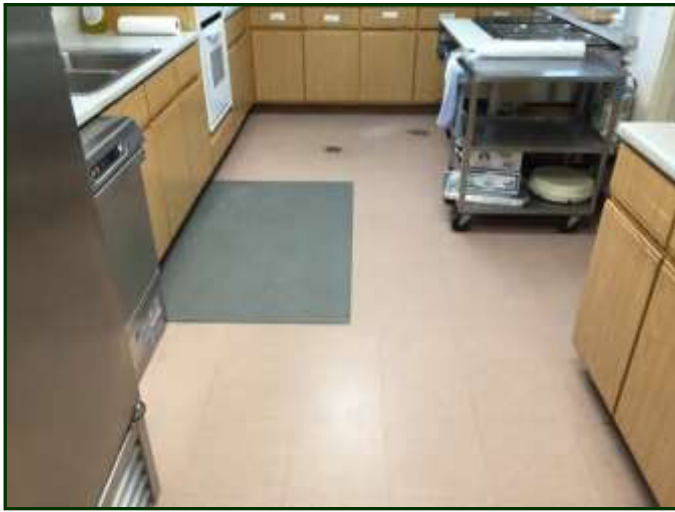
Photo #10: Photograph depicts general view of 12" Floor Tile within the Kitchen Area of the Addition Section.

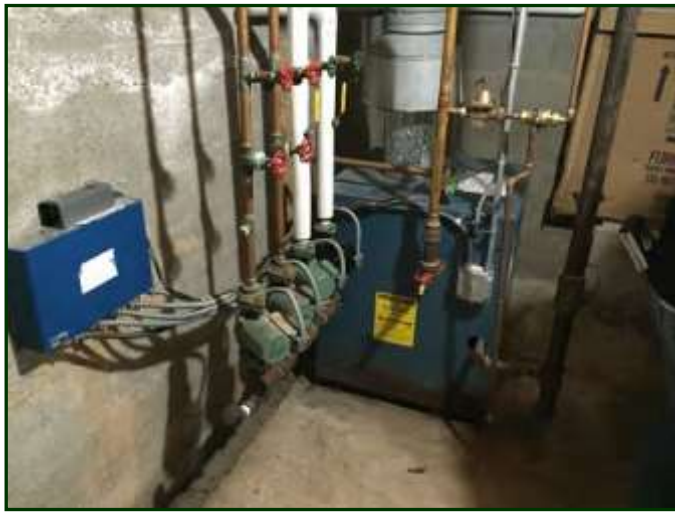
Photo #11: Photograph depicts general view of Gas Fired Boiler in Basement of the Original Section.

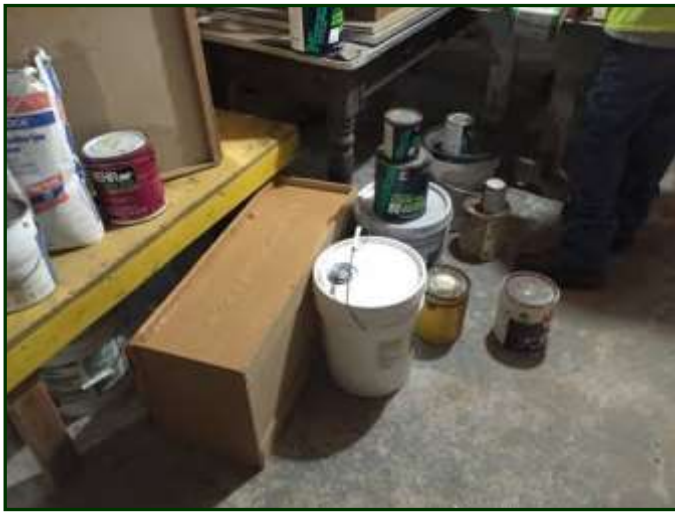
Photo #12: Photograph depicts general view of Paint and Adhesive Storage within Basement of the Original Section .
